**ELLIOTT BAY SEAWALL PROJECT SEASON 2 (2015)  
REVISED ACOUSTIC MONITORING REPORT  
(NWS-2011-778-WRD and NWR-2013-10650)**

**October 9, 2015**

City of Seattle Department of Transportation

**THE GREENBUSCH GROUP, INC.**

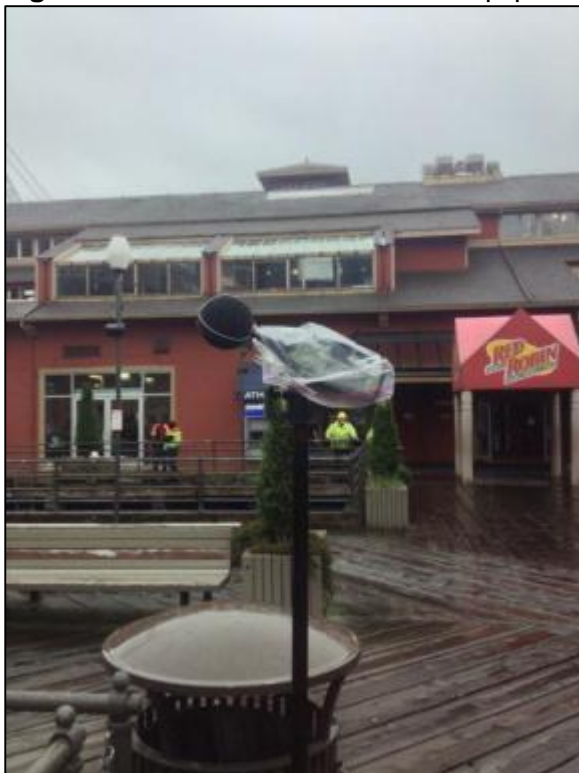
**Figure 6.1** Airborne Measurement Equipment

On October 30 and October 31, 2014, airborne sound levels were measured with the Brüel & Kjaer Type 2250 sound level analyzer. During these dates, two Reson TC-4013 hydrophones were attached to the PCB Model 482A16 signal conditioner. The signal conditioner was attached to the National Instruments NI USB-4431 4-channel data acquisition system, which transferred the data into a laptop. The laptop recorded the time waveforms from each pile driving event for subsequent signal analysis. This equipment setup allowed for real-time approximations of peak sound levels while the measurements were being performed. Photos illustrating the airborne and underwater measurement equipment used on October 30 and October 31, 2014 are provided in Figure 6.1 and Figure 6.2.

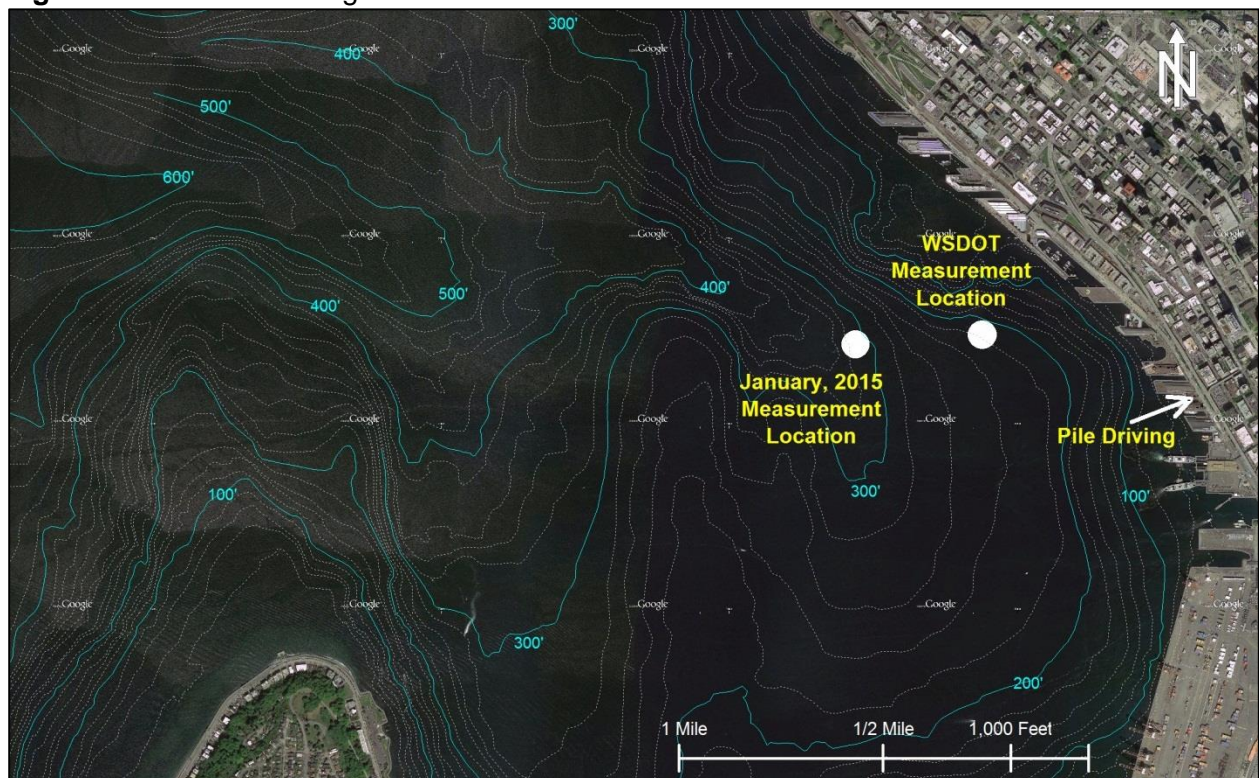
**Figure 7.1** Far Field Background Sound Level Measurement Locations

Short-term background sound level measurements were made approximately 1,200 meters to the west of Box 6 on January 3, January 7, and January 8, 2015 for approximately 1 hour during daytime hours. Measurements were conducted from a drifting boat. Data collection over three consecutive days was not possible due to adverse weather conditions. These measurements were used to verify that background sound levels measured by WSDOT during April 2011 had not changed significantly.

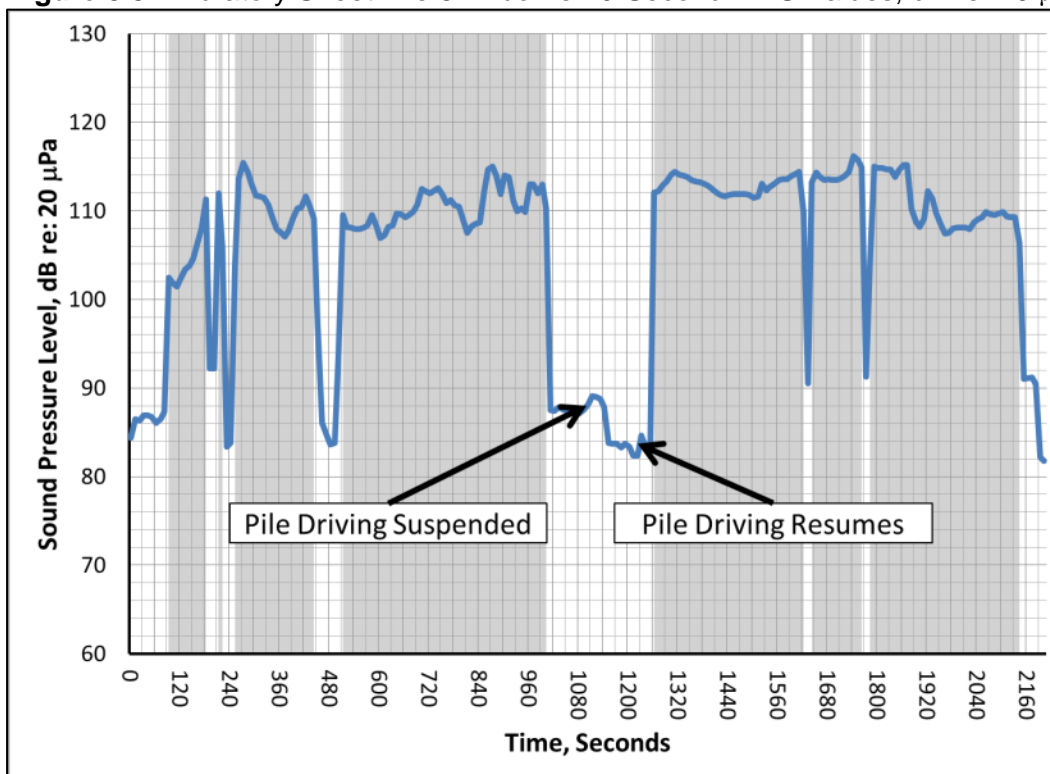
**Figure 8.34** Vibratory Sheet Pile 5 Airborne 10-Second RMS Values, dB re: 20  $\mu$ Pa

Note: Data collected between suspension of pile driving and the pile driving resuming is not shown.  
Source: The Greenbusch Group, Inc.

Airborne measurements conducted of sound generated by installation of vibratory sheet pile 5 during periods when the vibratory hammer was operating under full power were used to determine the range and average 10-second RMS values using data between 12.5 Hz and 16 kHz. As a result of the damage sustained to the laptop on October 31, 2014, the airborne measurement equipment was repurposed to collect hydroacoustic data. The Rion NL-32 was used to collect airborne spectral sound data and was only capable of measuring between 12.5 Hz and 16 kHz. Due to the time sensitive nature of the hydroacoustic monitoring (first 5 unobstructed piles require monitoring) there was insufficient time to rent additional equipment capable of measuring the full 10 Hz to 20 kHz frequency range.

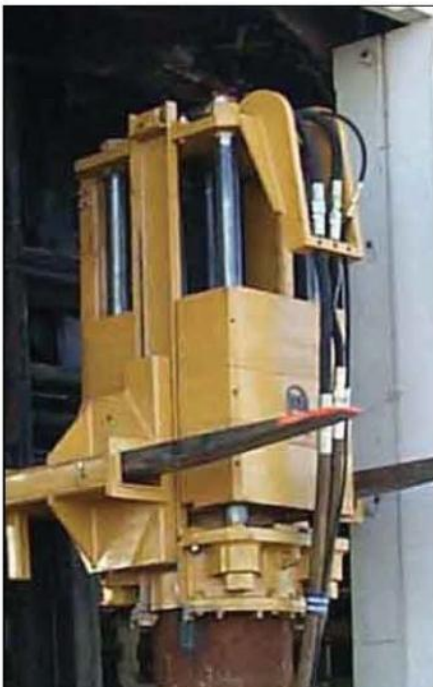
**Figure 12.2** Impact Hammer Information

Specifications	Standard	Metric
Ram Weight	12,000 lbs	5,443.11 kg
Rated Energy	24,000 ft-lbs	32.54 kNm
Stroke at Rated Energy	24 in	60.96 cm
Blows per Minute	45-75 min-max	
Weight without Insert	18,230 lbs	8,268.99 kg
Height	105 in	266.7 cm
Standard Lead Size	8"x26"
